**Heritage Item #**

MI Reference: 70 HCWA No: 16633	Place Name: Platelayers Cottage	Other Name/s: Fettle's Cottage; Cottage 746, Railway Cottage
		Date of Review: October 2021

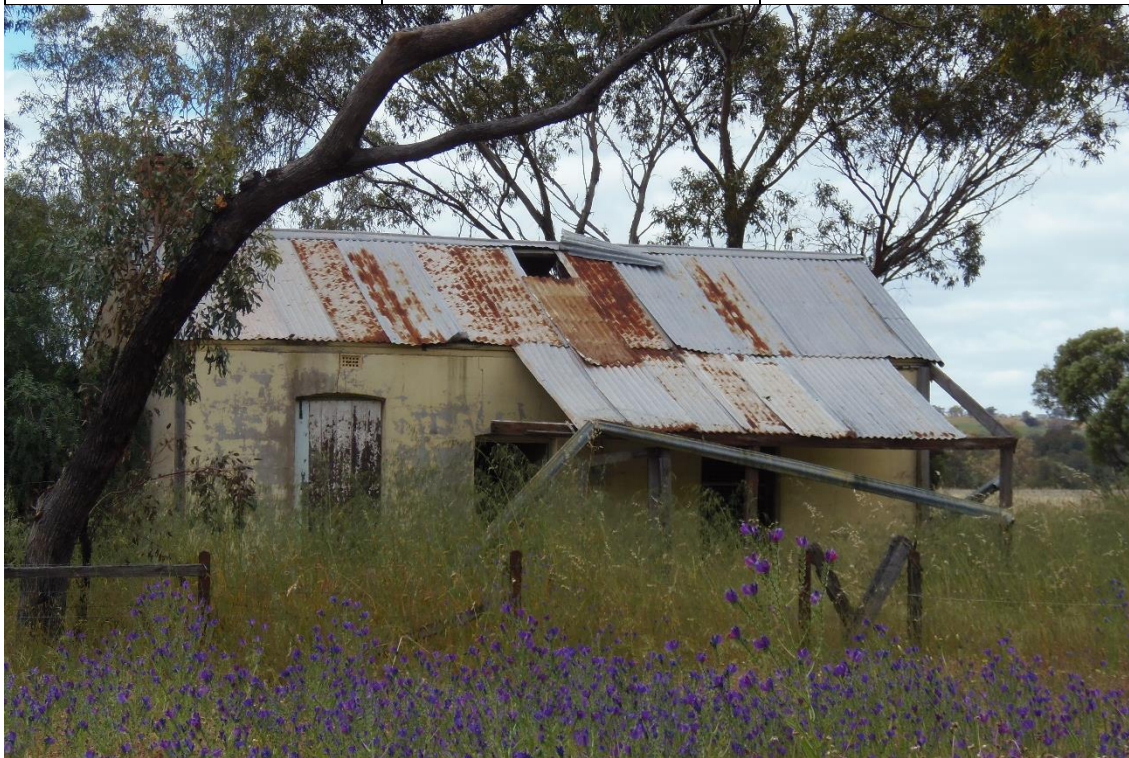
Address: Opposite 38 Rose Terrace, Spencers Brook	Lot No: 49 Property Key: Plan Diagram: D3029 Vol Folio: 1557/581 Assess No: A11019
Locality: Northam	GPS:
Current Use: Unoccupied	Original Use(s): Residence
<b>HERITAGE LISTINGS</b>	
Listings:	
<b>CONSTRUCTION</b>	
Date of Construction: c.1917	
Architect / Builder:	
Architectural Style: Federation Bungalow	
<b>PHYSICAL EVIDENCE</b>	
<p>Description:</p> <p>Platelayer's Cottage, located opposite 38 Rose Terrace in Spencers Brook, is a single storey rendered masonry building with a corrugated steel gable roof displaying characteristics of the Federation Bungalow style of architecture.</p> <p>The cottage is isolated in a field partially accessible via Rose Terrace. The cottage is in poor condition and appears to be abandoned. Some of the corrugated roof sheets are missing with significant oxidation to those remaining.</p> <p>There is a face brick chimney to the west of the cottage and a corrugated steel roofed verandah, supported by timber posts, along the southern elevation. The verandah has mostly collapsed with significant deterioration to the gutters and roof sheets. The windows and doors to the front façade are missing with one window enclosed by timber boards.</p> <p>An associated separate structure is located to the west of the cottage. It is in a dilapidated condition. Construction materials that are evident are brick, render and timber weatherboard. At the time of viewing (October 2021) a face brick chimney is</p>

evident. A hinged wall to the outbuilding is referenced in the previous inspection from 2012; however this was not viewed in October 2021. The surrounding land is overgrown and the site is not easily accessible; however, the former fence line is still evident. The cottage is surrounded by several mature eucalyptus trees.
Condition: Poor
<b>HISTORICAL</b>
Notes:
Theme: Workers and Rail and Light Rail Transport
Associations: State Wheat Scheme, Pat Lumis, Department for Planning & Infrastructure, Public Transport Authority, Greg Powers
Heritage Assessment or Conservation Plan:
Public Access: No
<b>SIGNIFICANCE</b>
Level of Integrity: Medium
Level of Authenticity: High
Statement of Significance:
Platelayers Cottage is of cultural heritage significance for the following reasons: <ul style="list-style-type: none"> <li>The place is a rare example of a brick and iron platelayer's cottage, and its hinged kitchen wall is an unusual vernacular adaptation to Australia's harsh climatic conditions.</li> </ul>

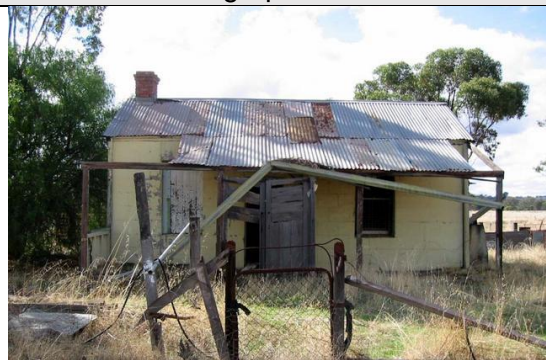
Front Façade Source: Municipal Heritage Inventory, 2012	Short sheet corrugated roofing Source: Stephen Carrick Architects October 2021

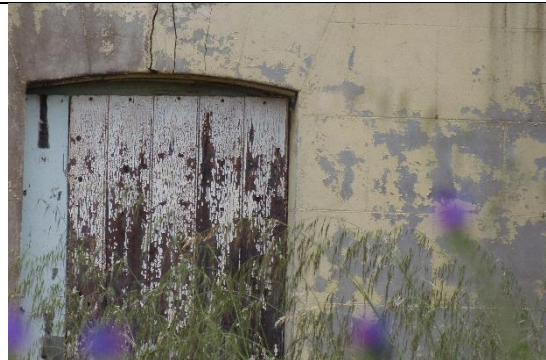
Timber boards to window opening Source: Stephen Carrick Architects October 2021	Gate to property Source: Stephen Carrick Architects October 2021

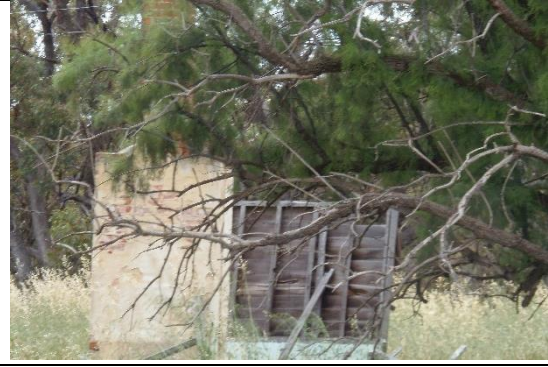
Associated structure  
Source: Stephen Carrick Architects  
October 2021

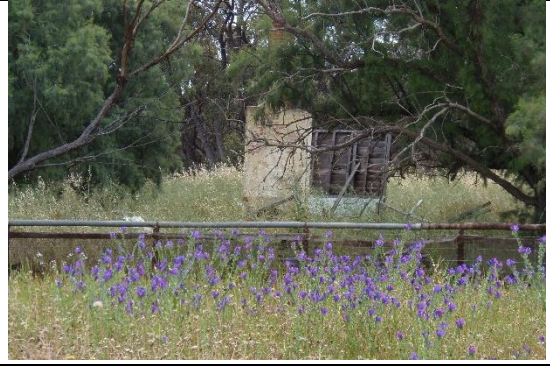
Associated structure  
Source: Stephen Carrick Architects  
October 2021
